EAST BOSTON CAMPS

Building Evaluation

November 2, 2007

Re: East Boston Camps (EBC) Building evaluation.

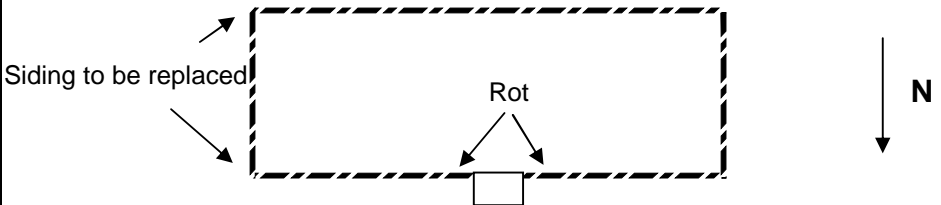
Conditions								
Roof	F	Damage surrounding chimney						
Visible Rot (Y/N)	Y	Total Linear Feet	2.5*4 / 2.5*4	Location	Left			
Siding Damage (Y/N)	Y	Total Linear Feet	5.5'	Location	Front 3'	Right 2.5'		
Needs Painting (Y/N)	Y							
Threshold	G							
Footings	NV							
Steps	G							
Railings	M	Total Linear Feet	3'	Missing				
Doors	F	Sticks						
Shutters (Y/N)	Y	Functional						
Chimney (Y/N)	Y	Cracking and Damage - Needs to be removed and sealed						
Windows	F							
Handicap Accessible (Y/N)	N							
Deck (Y/N)	N	Condition						
Gutter (Y/N)	Y	Condition	Poor	Location	Front			
Additional Comments		Sketch

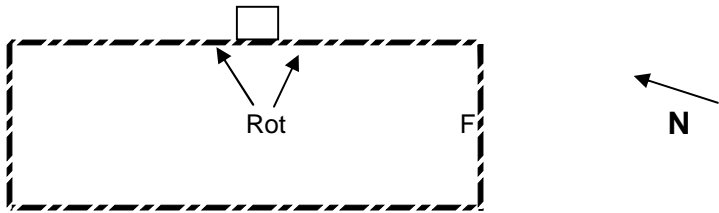
Conditions							
Roof	F	Damage and rot surrounding chimney					
Visible Rot (Y/N)	Y	Total Linear Feet	2.5*4 / 7.5*4	Location	Surrounding chimney		
Siding Damage (Y/N)	Y	Total Linear Feet	7'	Location	Left		
Needs Painting (Y/N)	Y						
Threshold	P	Needs immediate replacement, very rotted out.					
Footings	NV						
Steps	Y	Needs fill to surround base or additional step needs to be added					
Railings	P	Total Linear Feet	5	Needs removal or replacement			
Doors	F						
Shutters (Y/N)	Y	Rear of building has a single shutter missing					
Chimney (Y/N)	Y	Clay pipe stack should be removed					
Windows	F	Right side has rot that should be replaced on window sill near fireplace					
Handicap Accessible (Y/N)	N						
Deck (Y/N)	N	Condition					
Gutter (Y/N)	Y	Condition	Poor	Location	Front		
Additional Comments		Sketch

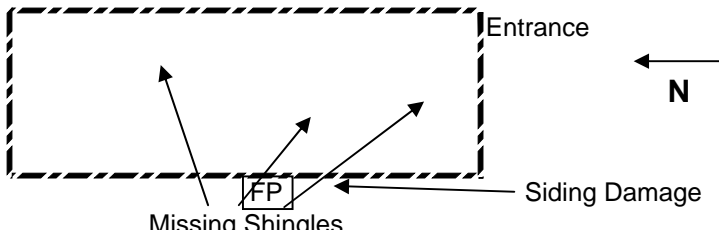
Conditions								
Roof	F	Missing shingles, suggest roof replacement						
Visible Rot (Y/N)	N	Total Linear Feet		Location				
Siding Damage (Y/N)	Y	Total Linear Feet	11'	Location				
Needs Painting (Y/N)	Y							
Threshold	F							
Footings	NV							
Steps	F							
Railings	F	Total Linear Feet	3'					
Doors	F							
Shutters (Y/N)	Y	Good						
Chimney (Y/N)	Y	Abandoned, should be removed. There are no pipe risers higher than roof line.						
Windows	F							
Handicap Accessible (Y/N)	N	OK						
Deck (Y/N)	N	Condition						
Gutter (Y/N)	Y	Condition	Poor	Location	Front			
Additional Comments		Sketch

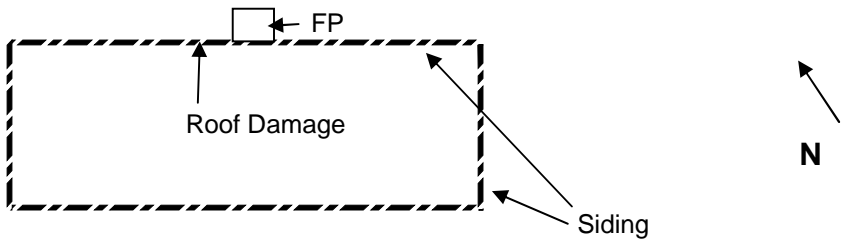
Conditions								
Roof	F							
Visible Rot (Y/N)	N	Total Linear Feet	20'	Location	Chimney			
Siding Damage (Y/N)	Y	Total Linear Feet	36'	Location	Front 16'	Rear 16'		
Needs Painting (Y/N)	Y							
Threshold	F							
Footings	NV							
Steps	G							
Railings	F	Total Linear Feet	3'	Not connected to wall				
Doors	F	Does not close well, Tight - difficult to close						
Shutters (Y/N)	Y	Fair, some damage						
Chimney (Y/N)	Y	Damage at right side, some rot above roofline / no pipes						
Windows	F							
Handicap Accessible (Y/N)	N	OK						
Deck (Y/N)	N	Condition						
Gutter (Y/N)	N	Condition		Location				
Additional Comments		Sketch

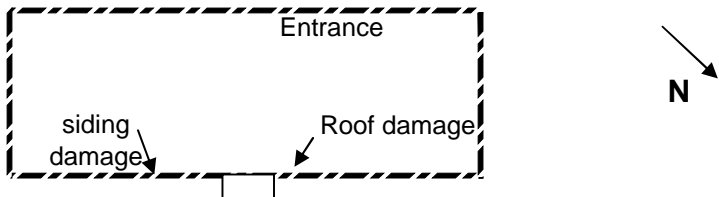
Conditions								
Roof	F	Damage to the right side of chimney						
Visible Rot (Y/N)	Y	Total Linear Feet	8'	Location	Right 8'			
Siding Damage (Y/N)	Y	Total Linear Feet	62'	Location	Right 29'	Left 17'	Rear 16'	
Needs Painting (Y/N)	Y							
Threshold	P	Needs replacing / sill damage as well						
Footings	F							
Steps	F							
Railings	N	Total Linear Feet						
Doors	F							
Shutters (Y/N)	N							
Chimney (Y/N)	Y	2 pipes extended above roofline / rot on the right side roof / brick construction						
Windows	NV							
Handicap Accessible (Y/N)	N	OK						
Deck (Y/N)	N	Condition						
Gutter (Y/N)	N	Condition		Location				
Additional Comments		Sketch
